FINAL REPORT
ACCIDENT TO
NOMAD N22B 9M-ATZ
KOTA KINABALU
6th JUNE, 1976

AIRCRAFT ACCIDENT
REPORT NO :1/76

AIRCRAFT TYPE & REGISTRATION: Nomad N22B, 9M-ATZ

DATE & TIME: 6th June, 1976 at 1542 hours.
All times in this report are local time Sabah/Sarawak.

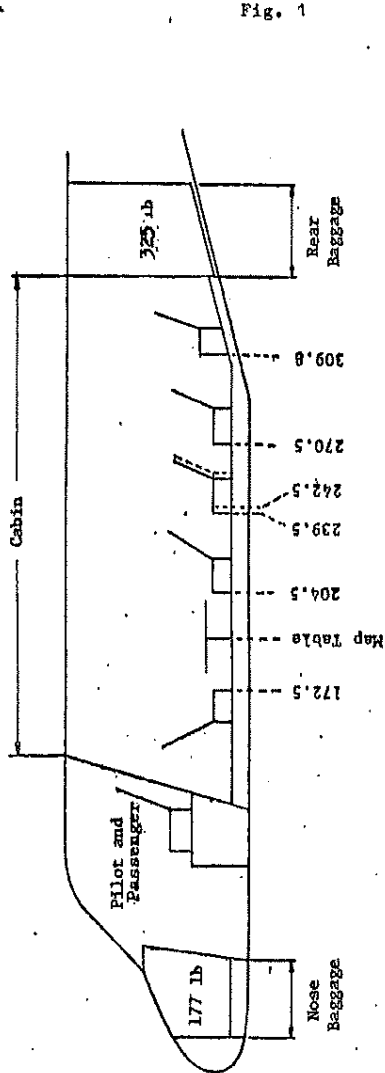
Fig. 1

$$\text{FOR ACCIDENT CASE} = 43.76\% \text{ MAC}$$

- Notes: 1. MAC loading edge datum is 172.26 ins. aft of datum.
2. Mean Aerodynamic Chord is 71.00 ins.

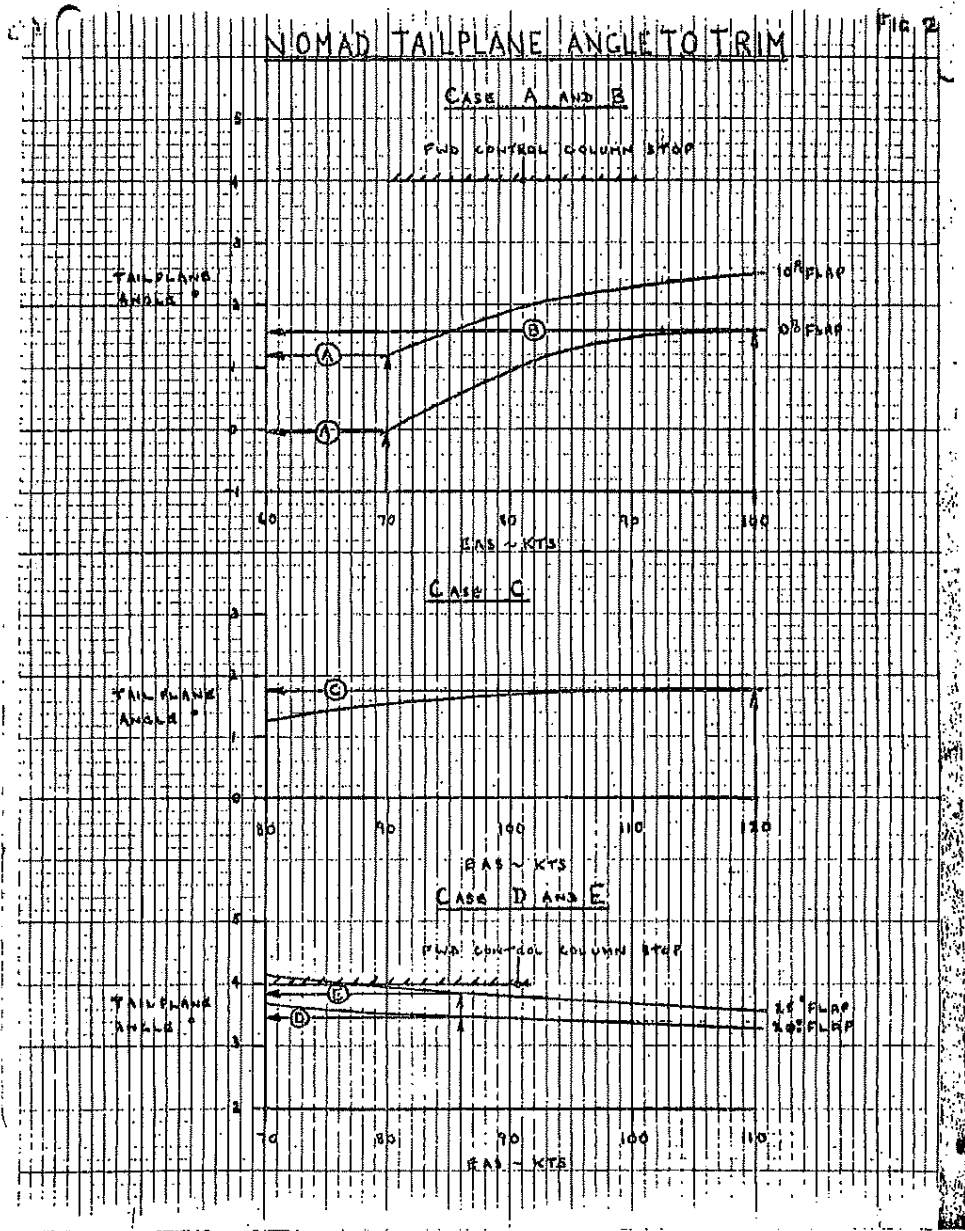
To consider the second question first it is necessary to study the implications of Fig. 2. From this figure it can be seen that the point of running out of forward control column movement is a function of four factors, namely centre of gravity position, flap position, power setting and to a lesser extent airspeed. The figure demonstrates that as flaps are lowered the tailplane incidence is increased (control column moving forward) significantly with the worst case at 25° of flap. Also clear is that when both power is increased or centre of gravity moves aft the tailplane incidence is again increased. By comparing Cases A, B, C, D and E which cover the various phases of the fatal flight it becomes clear why the aircraft was able to complete the earlier part of the flight without loss of control.

So that paragraph 2.1 Analysis may be understood it is necessary to consider the position of the control column for the various phases of flight. The following cases are intended to illustrate the various conditions of flight experienced in a tabular form for ease of reference. The first column is intended to allow easy cross reference to the graph. Column three to six are intended to give the actual flight parameters assumed in arriving at the tailplane angles listed.

CASE	FLIGHT PHASE	C OF G POSITION % MAC	POWER PSI	AIRSPEED KTS	FLAP POSITION	TAILPLANE ANGLE	REMARKS
A	Take Off	43.60	90+	70	0 or 10	-0.04 or 1.1	Safe
B	Climb	43.60	90	100	0	1.57	Safe
C	Cruise	43.70	60	120+	0	1.76	Safe
D	Initial Approach	43.76	30	86	20	3.46	Moving towards forward stop
E	Final Approach	43.74	30	86	25	3.85	Almost on stop no margin for transient excursions

Therefore it can be seen that the flight could be carried out successfully up to the approach phase where it can be seen that the control column is moving towards the forward stop in the initial approach and probably reached the forward stop when an attempt was made to check the nose pitch up as the flaps were passing 25° with power set about 30 psi.
